## W5300 Errata Sheet

W5300 Errata Sheet

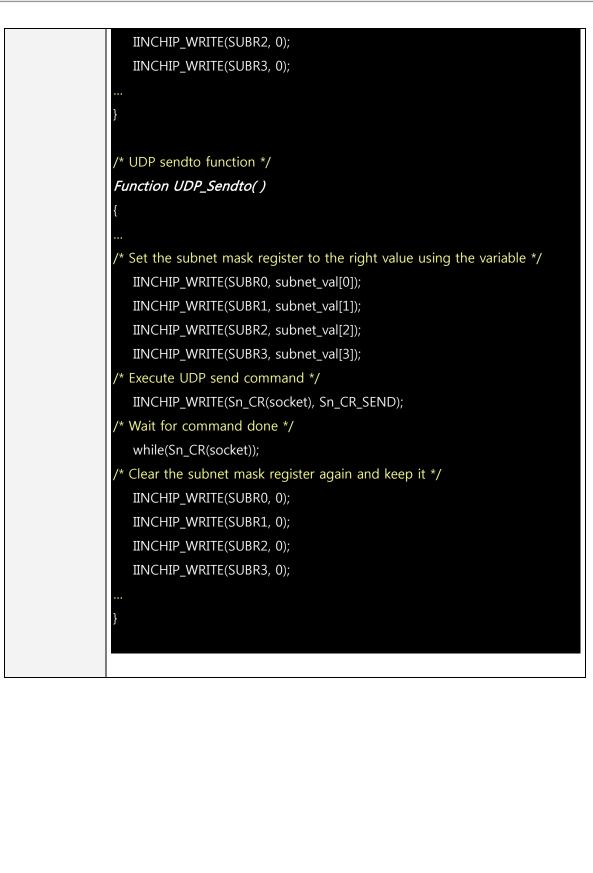
mask register and sending the ARP r	equest.		
		o "0.0.0.0" and keeping it but save th		
	C C	al variable when you initialize the W5300		
		n TCP or send command in UDP, set th		
	5	value using the variable before executin		
	6 6	one connect or send command, clears th		
Solution &	subnet mask register again to keep its value to "0.0.0.0"			
Recommendat	Before Applying (without solution)	After Applying (with solution)		
ion	W5300 Initialization	W5300 Initialization		
	Set GW : 192.168.1.254 Set IP : 192.168.1.2 Set SN: 255.255.255.0	Set GW: 192.168.1.254 Set IP: 192.168.1.2 Set SN: 0.0.0.0 & save the SN to global variable.		
		TCP Connect UDP Send		
	"E	t SN from global variable xecute connect command" ear SN : 0.0.00

IINCHIP\_WRITE(SUBR1, 0);

Erratum 4				
Phenomenon	The W5300 replies with gatewa	ay IP address for the ARP request from		
	normal node which has "0.0.0.0	" IP address. But normally the W5300		
	should replies with target IP a	ddress "0.0.0.0" not the gateway II		
	address.			
Condition	Normal Node↔           IP: 0.0.0.0↔           SN: 255.255.255.0↔           Wrong Targe	Request <sup>12</sup> withe <sup>1</sup> et IP address: <b>192.168.1.254</b> <sup>12</sup> SN: 255.255.255.0e <sup>1</sup> GW: 192.168.1.254e <sup>1</sup> GW: 192.168.1.254e <sup>1</sup>		
	misunderstands the node locates	is subnet calculating logic. The W530 s other sub-network when target ha 00 set the target IP to the gateway II ARP reply.		
	To avoid this erratum we must kee	ep the subnet mask register value to zero		
	except two cases which are "CC	NNECT" command in TCP and "SEND		
	command in UDP. Because only th	nese two cases are referring the subne
